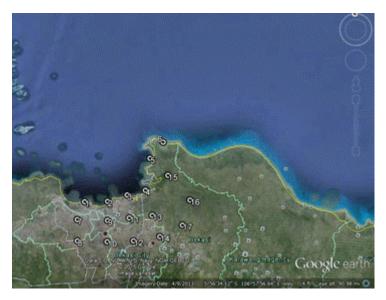
Note : O1 – O17 : sampling plots Figure 1. Research Site

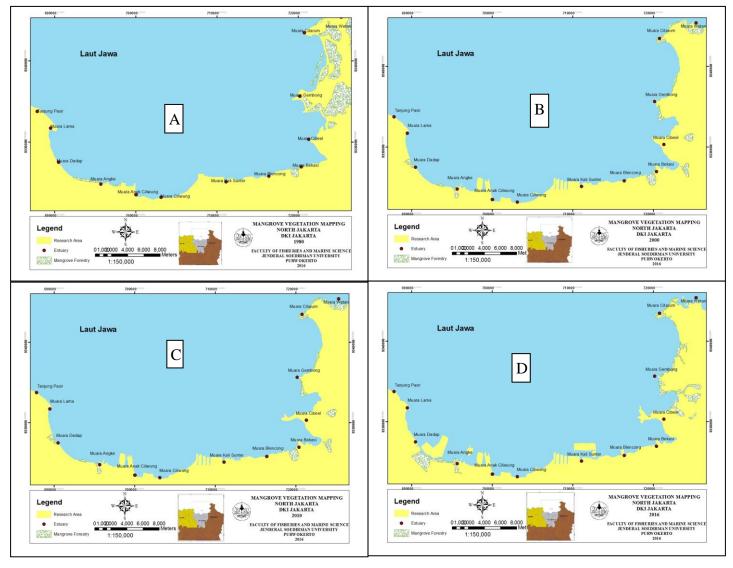
Noted : A : North Jakarta Coast on 1980 B : North Jakarta Coast on 2000

C : North Jakarta Coast on 2010

D : North Jakarta Coast on 2016

Figure 2. The Dynamic Mapping of Mangrove ecosystem

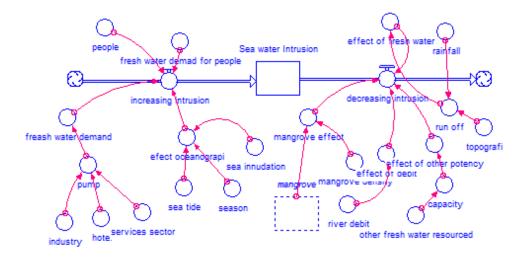
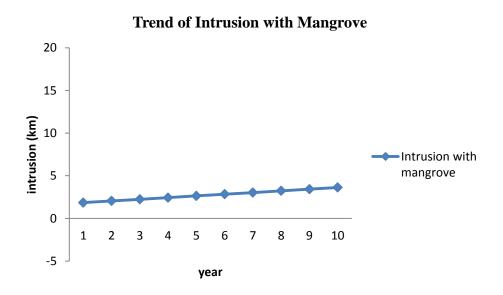
Figure 3. Sea Water Intrusion with Mangrove Vegetation as a System Component

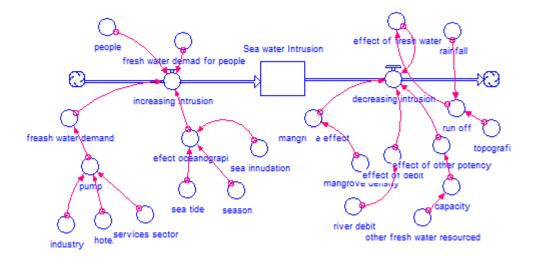
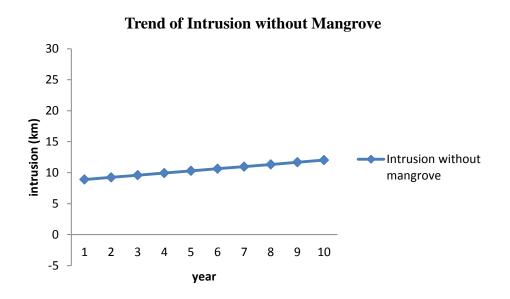
Figure 4. Sea Water Intrusion without Mangrove Vegetation as a System Component

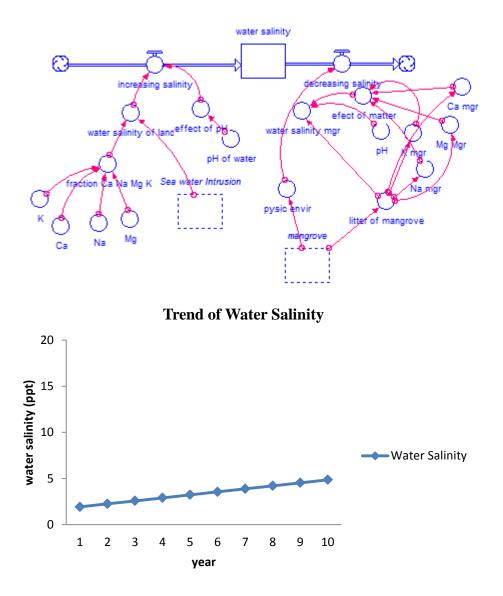
Figure 5. Trend of Water Salinity in Jakarta

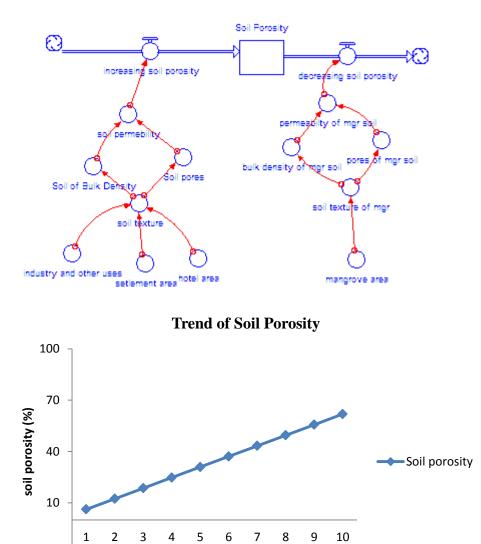
Figure 6. Trend of Soil Porosity in Jakarta.

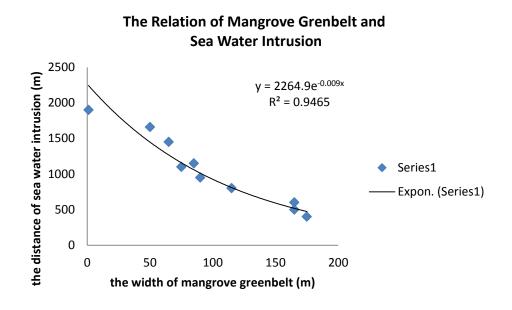
Figure 7. The relation between sea water intrusion with mangrove greenbelt

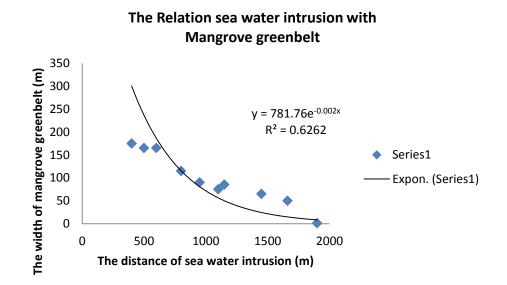
Figure 8. The relation between mangrove greenbelt with sea water intrusion
